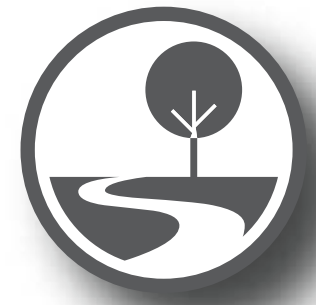
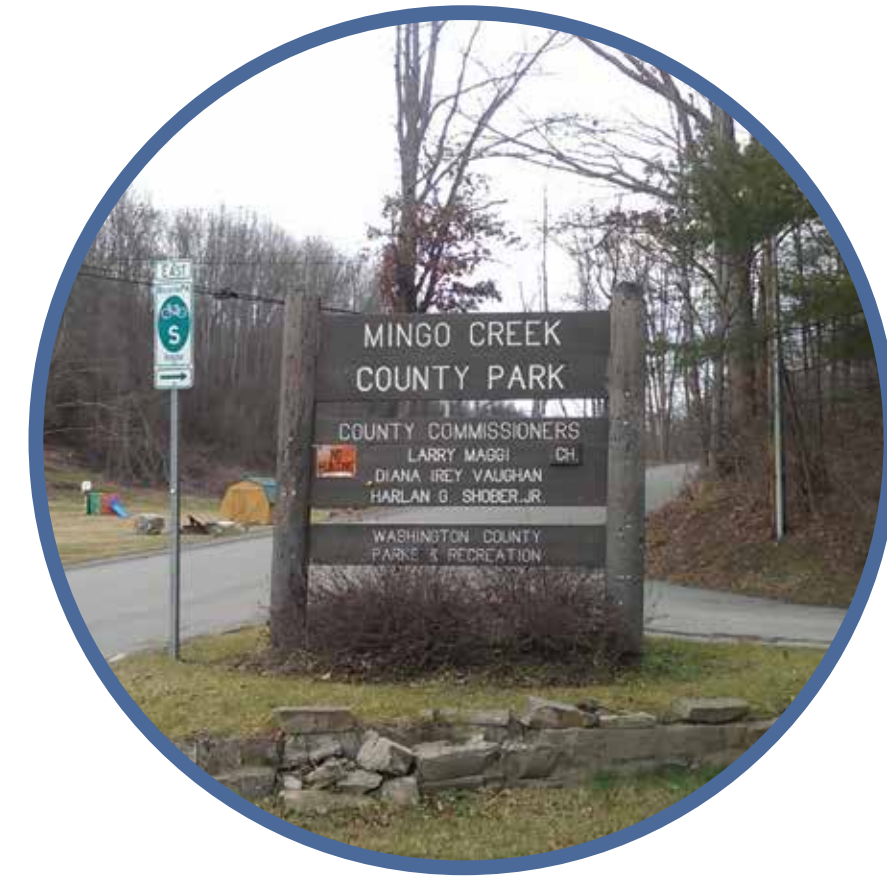
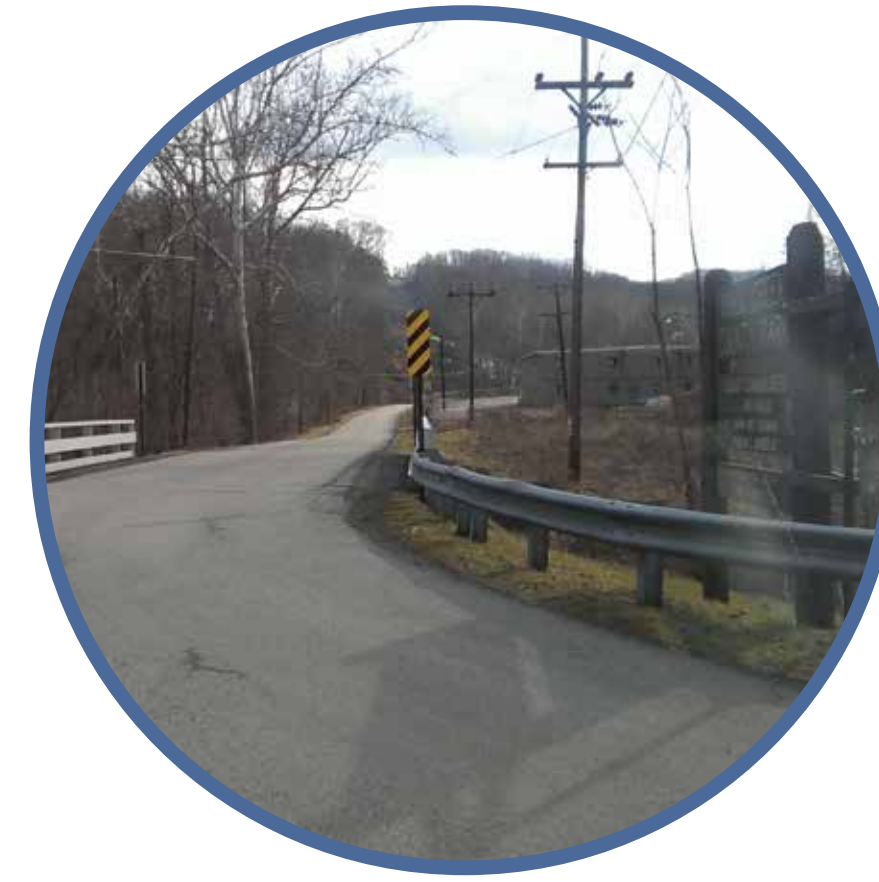
Park Entrance

- Mingo Creek Road / Sugar Run Road
- Mingo Creek Road / Little Mingo Creek Road

- Entry announced at intersection of Sugar Run Rd and Mingo Creek Rd and at Little Mingo Creek Road and Mingo Creek Road
- Gateway signs are constructed of rough cut lumber and carved lettering
- Mingo Creek Rd runs along Mingo Creek, bisecting the park
- Most of Mingo Creek Rd is paralleled by a paved walking and biking trail

- Improve entrance aesthetics: Improve/enhance signage visibility, add plant material
- Consider connecting the paved trail to the park entrance to provide direct multi-modal access from Sugar Run Rd into the park

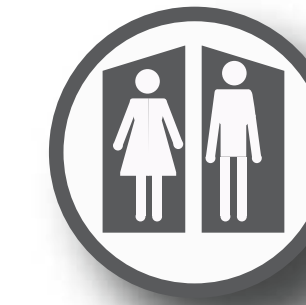
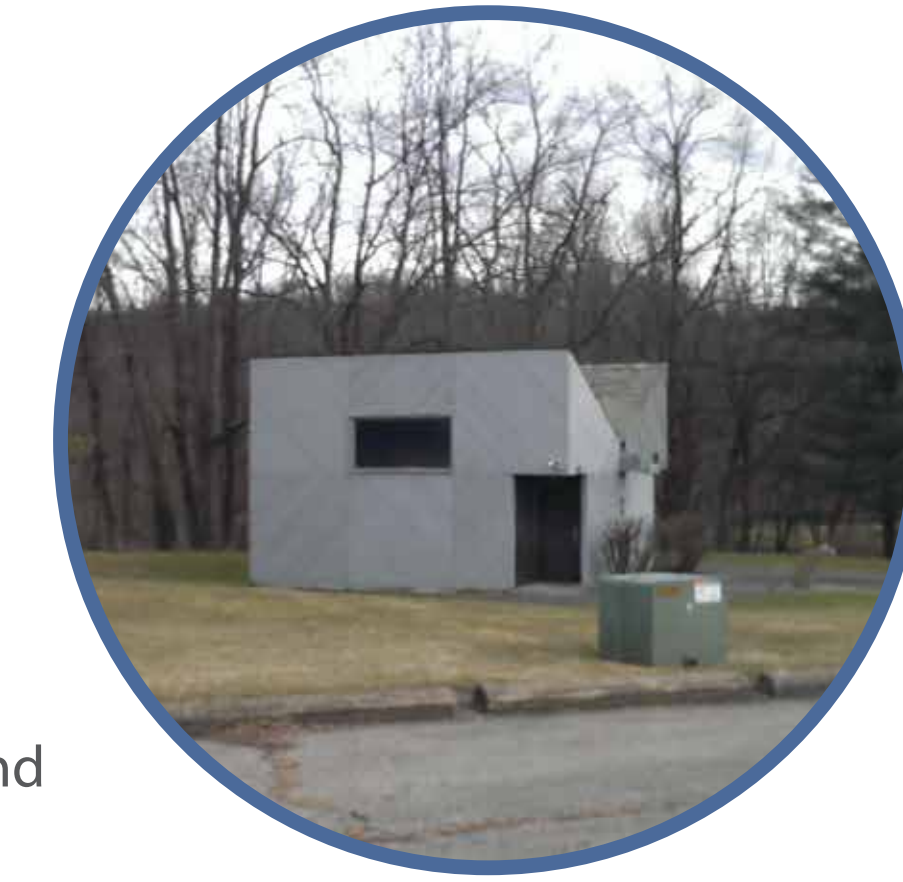
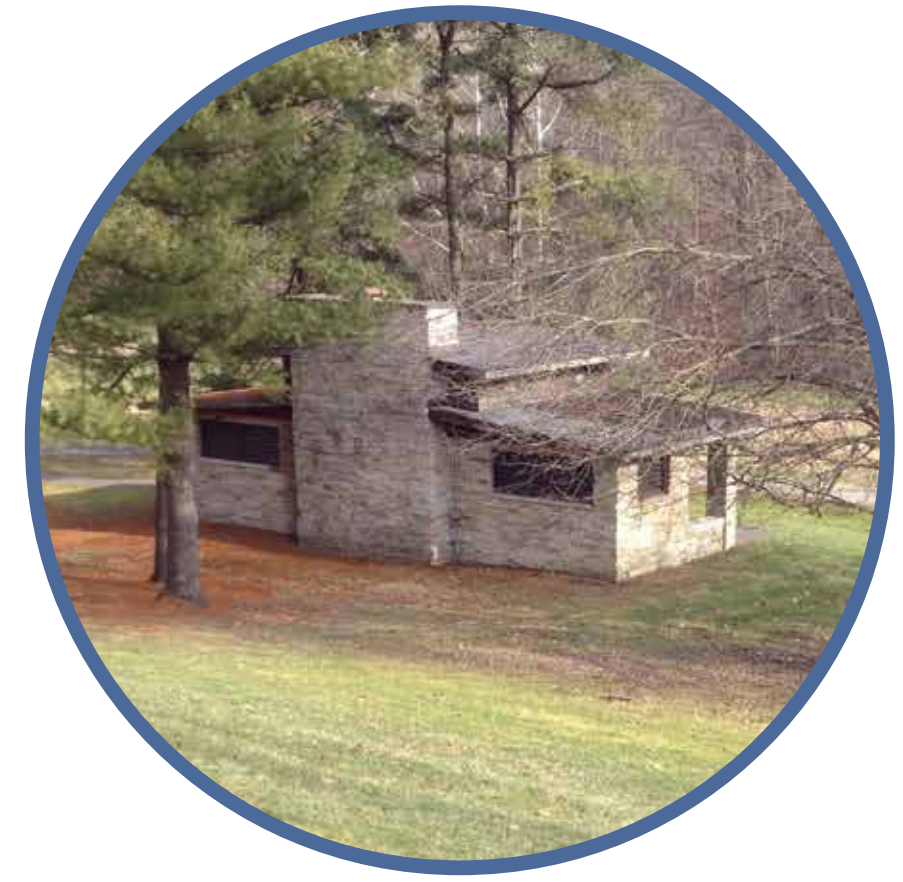
Restrooms

- Most of the restroom facilities are dated and are in need of upgrades / repairs
- Distribution of restrooms throughout the park seems acceptable
- The architectural style is unique and is perhaps a relic of a past trend

- Improve current restroom facilities by upgrading fixtures and remodeling the facades
- Replace current restroom facilities and consider consolidating restroom structures in areas where proximity allows

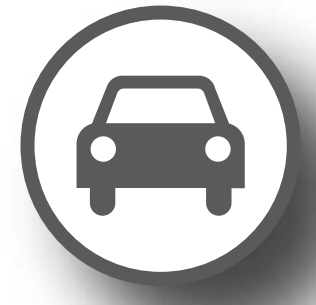
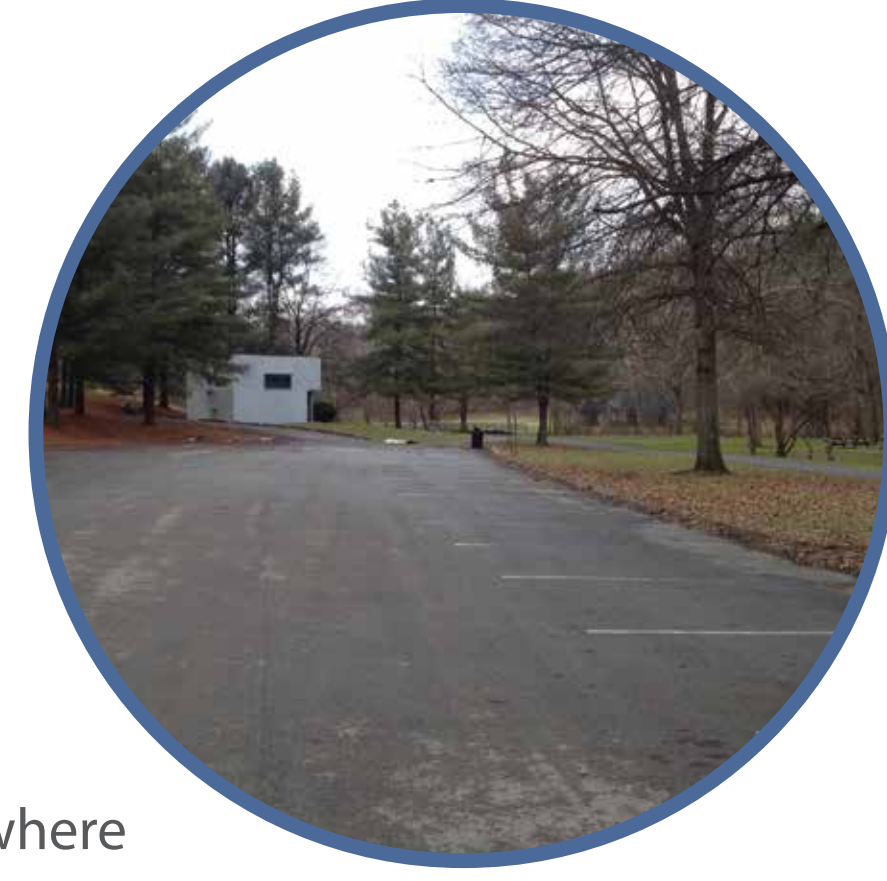
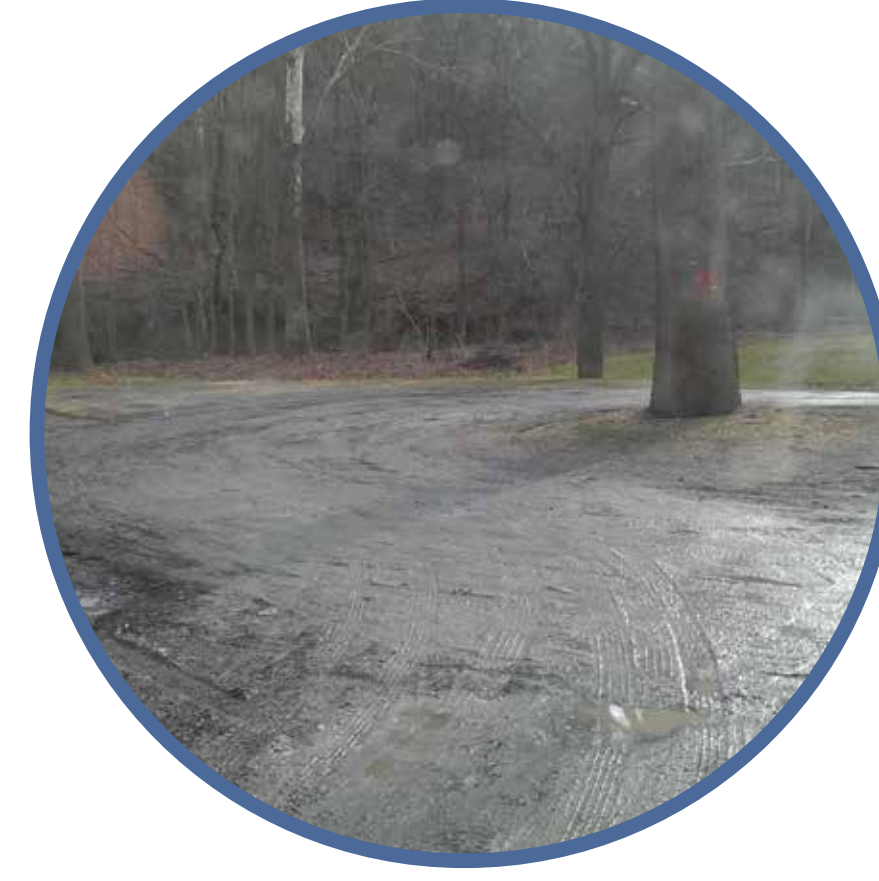
Parking

- Each cluster of park amenities (shelters, restrooms, playgrounds, etc.) has a designated parking area
- In all, parking is not centralized due to the linear layout of the park along Mingo Creek and the distance between each amenity.
- Some small, informal road side parking exists intermittently throughout the park where larger paved lots are not within close proximity.

- Promote more pedestrian activity by centralizing parking when possible
- Where appropriate, implement sustainable stormwater management strategies to reduce runoff into Mingo Creek

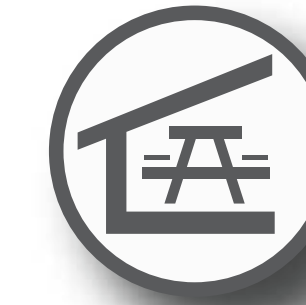
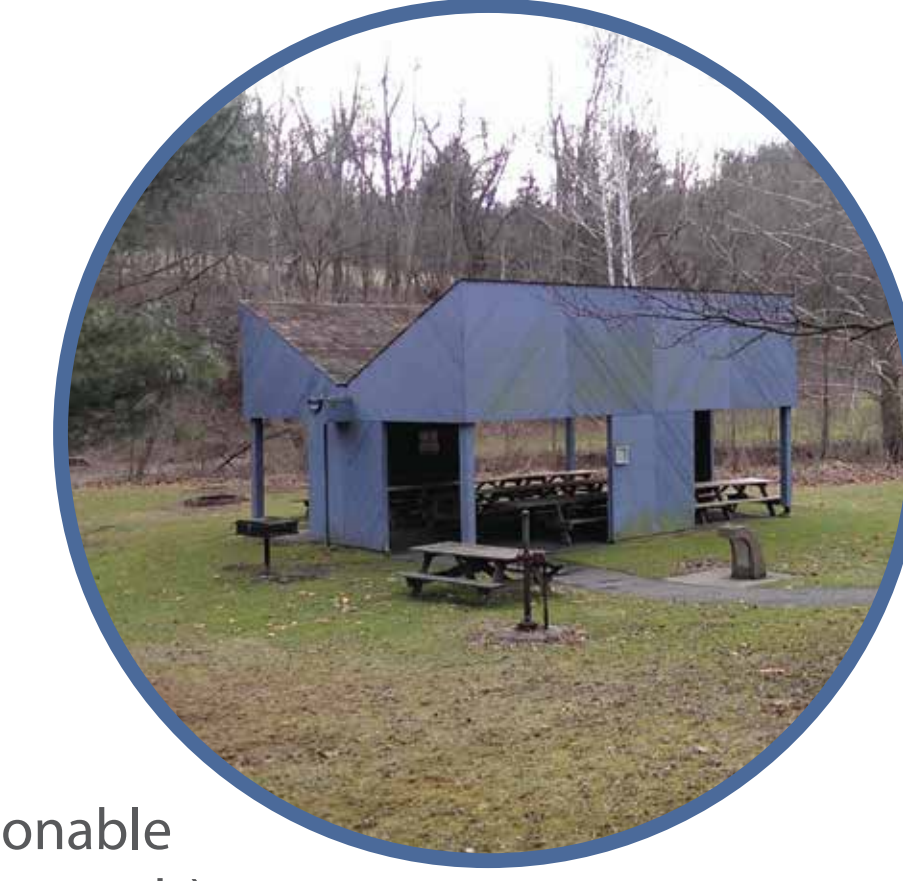
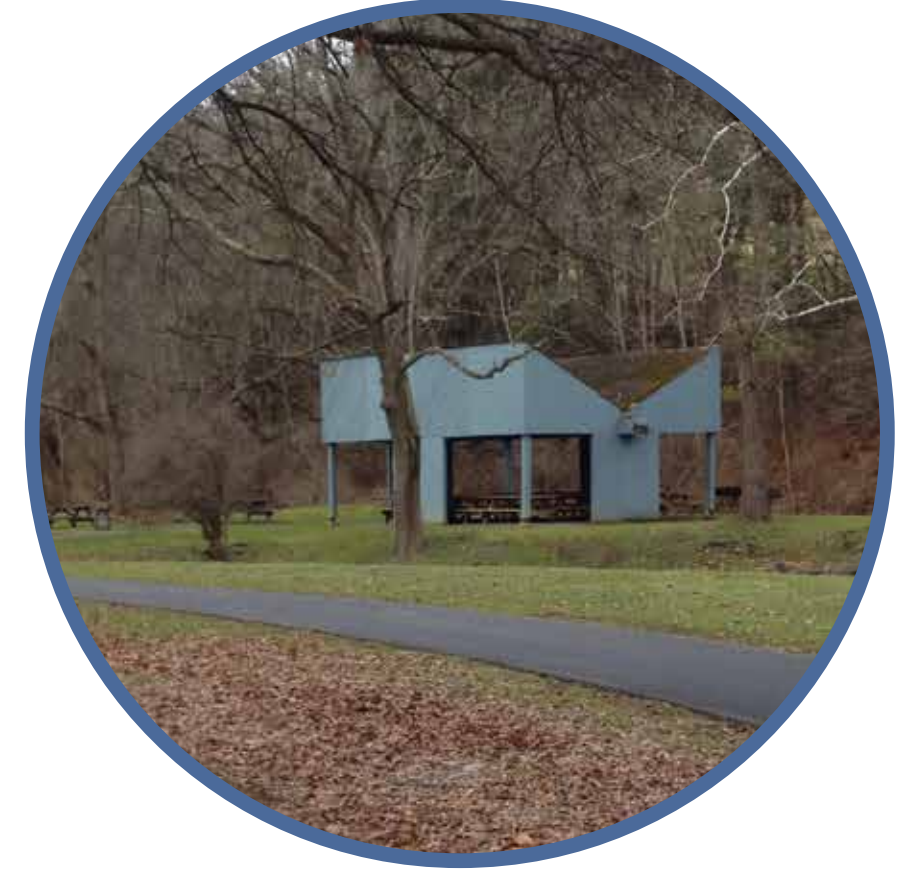
- Most shelters are dated and are in need of remodeling or replacement
- The structures share the same unique architectural style as the restrooms
- Shelters are located in clusters throughout the park and are in reasonable proximity to restroom facilities and other park amenities (i.e., playgrounds)

- Consider replacing or performing major renovation of existing shelters
- Consider new shelters with a more timeless architectural style
- Provide small shelters along hiking and horseback trails as a destination for hikers

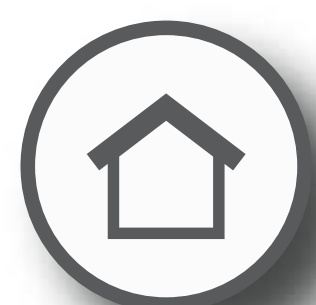
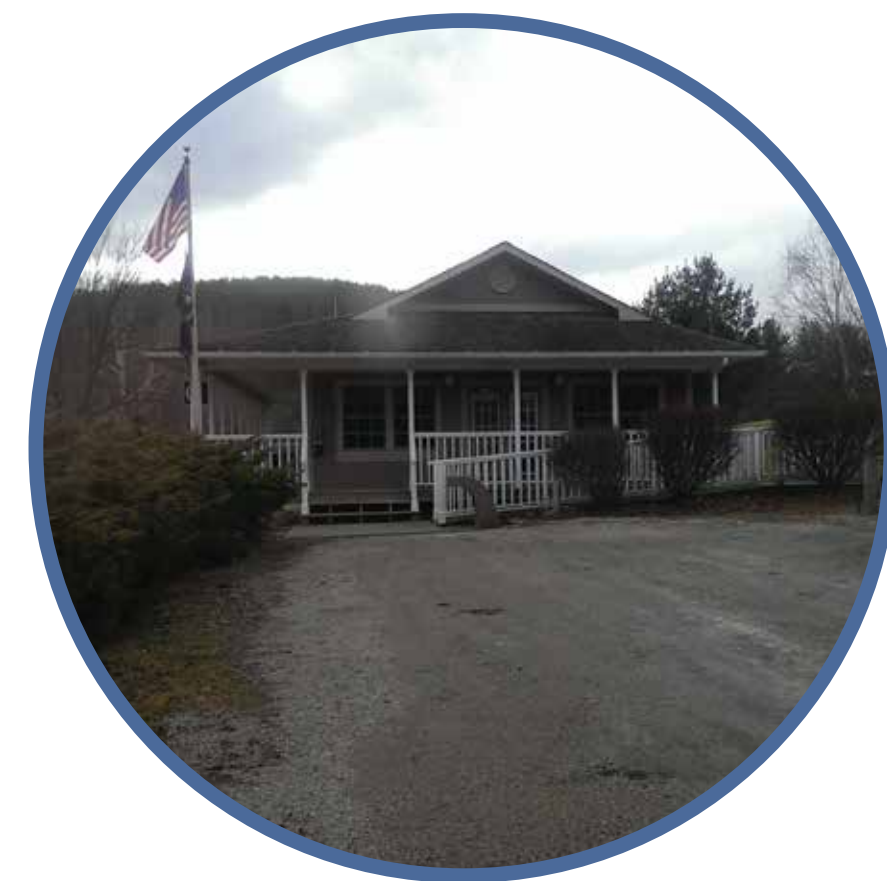
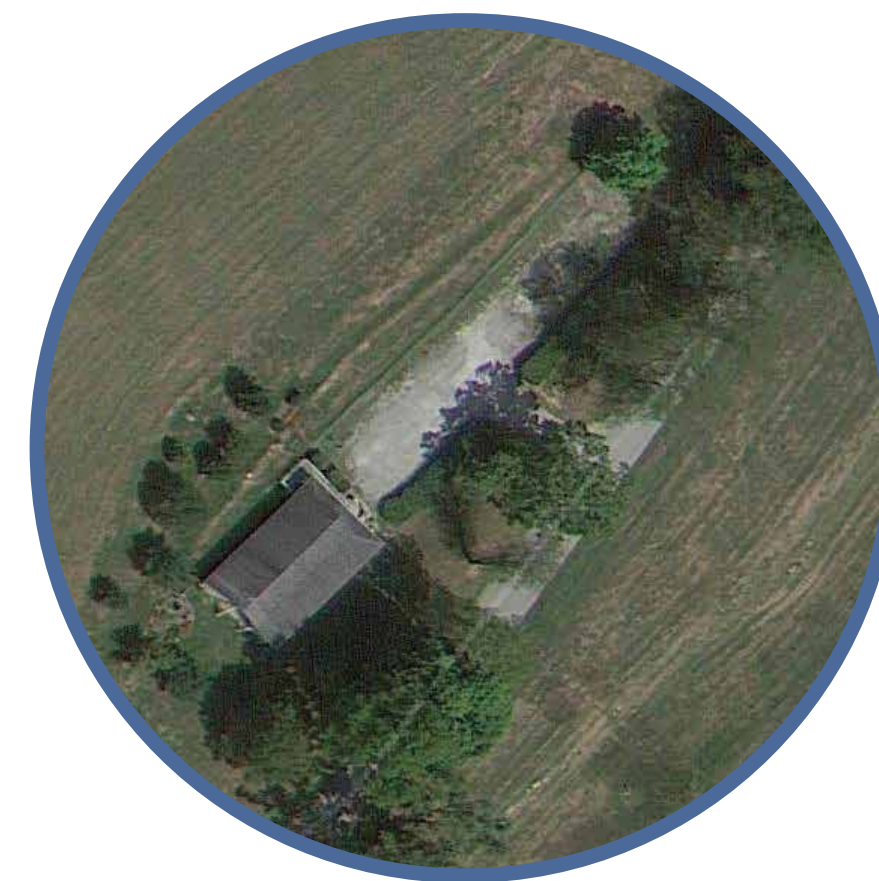
Park Office

- Park office has limited parking and isn't wide enough for 90 degree parking spaces.
- The building has a residential character and is primarily utilized for park staff office space
- Office does not have ADA access from Mingo Creek Rd.
- Often used for indoor programs or as a meeting location for program attendees

- Widen the parking area to improve its functionality
- Improve pedestrian access to the office to allow park visitors to access the office for information
- Consider expanding office to accommodate indoor activities or creating an additional structure elsewhere to alleviate space issues

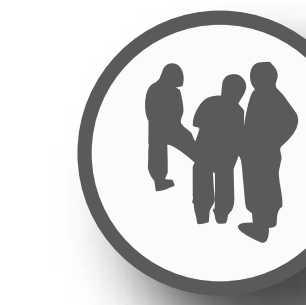
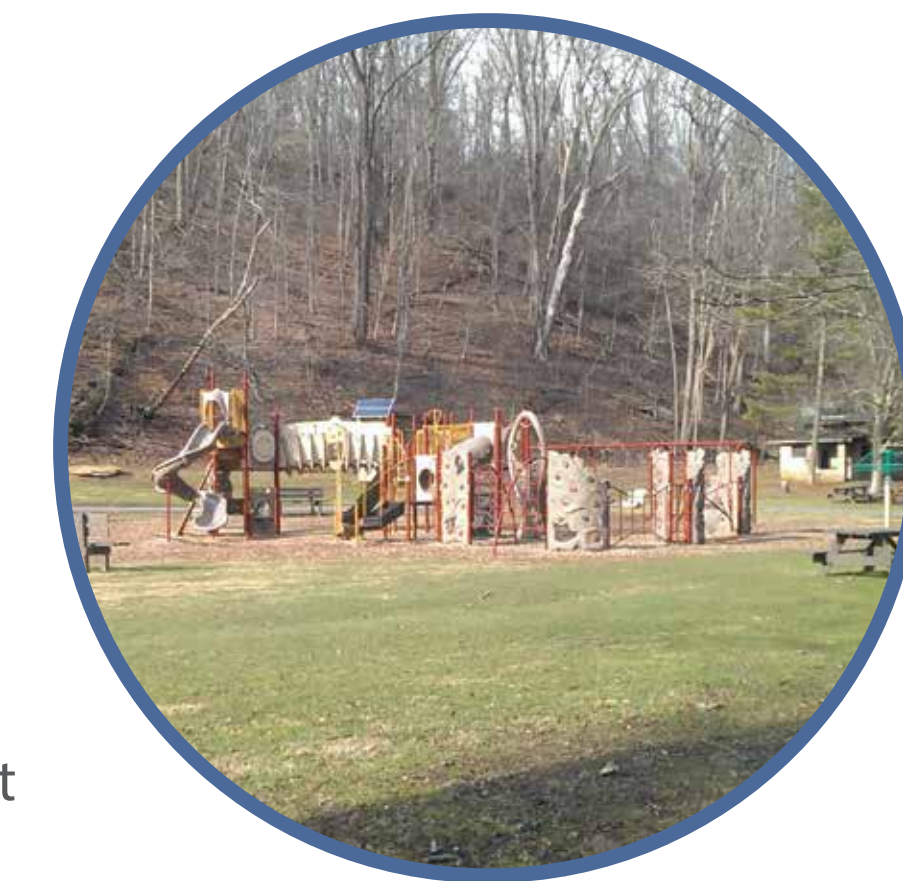
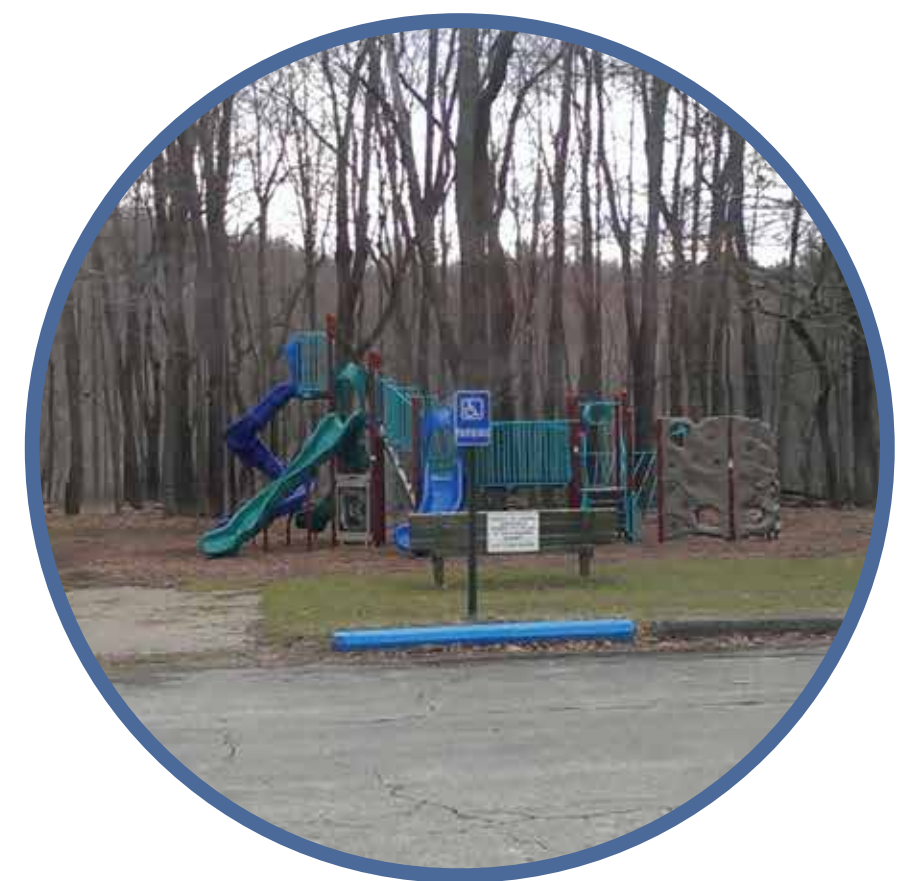
Playgrounds

- Three (3) formal playgrounds are located throughout the park
- All playgrounds are within a close proximity to shelters and restrooms
- All of the formal playgrounds utilize manufactured play equipment and structures

- Consider less formal play structures than encourage interaction with nature
